Customer Case Study: Detection of a bearing failure in an extruder gearbox

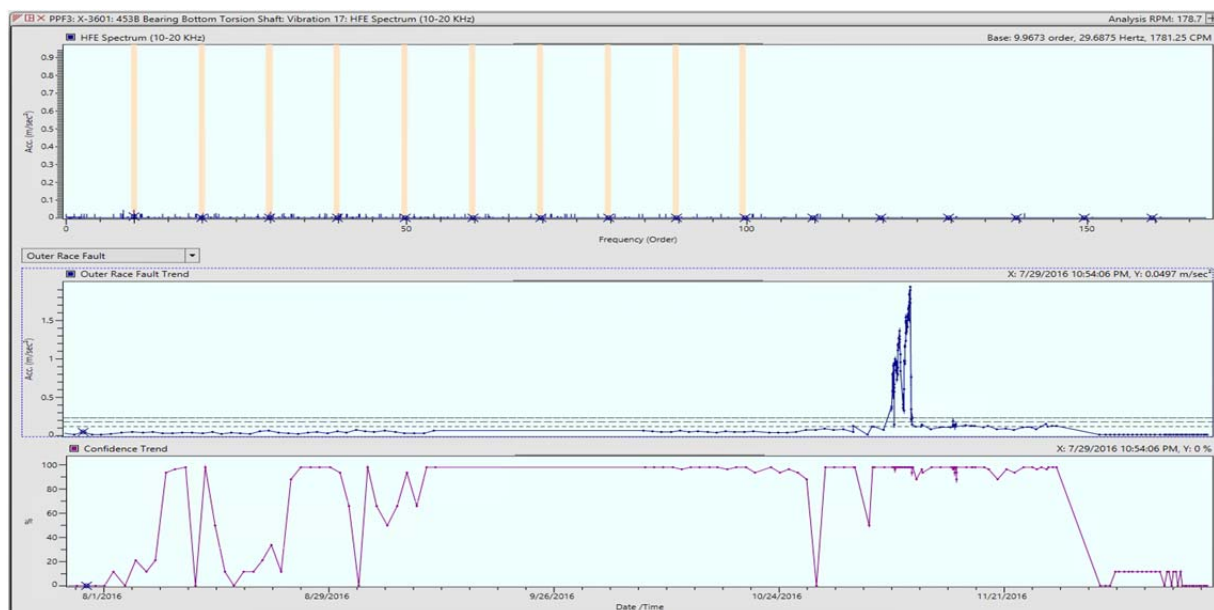
The three months of the trend with the rising confidence factor, the violated thresholds and the back in good condition after maintenance. The trend started in July 2016 until the failure occurred in November.

Starting three months before the failure occurred, no indications were visible. In early August, the patented PROGNOST®-Predictor Confidence Factor raised, but no changes in the acceleration spectrum could be detected. After the HFE spectrum was inspected, small peaks within the failure bands were visible what indicated an upcoming failure. This led to slowly increasing HFE and acceleration spectra over the next three months until the first warning level got violated in the early November. After this period of slowly increasing values (range of 0.1 m/sec^2), the values increased significantly (starting with 0.1 m/sec^2 to 2 m/sec^2) within a couple days. At all not only one single sensor showed the problem it was the mixture of different sensors and the unique Confidence Factor which are pinpointing the problem finally to "bearing damage". This led to the decision to stop the gearbox which was done based on close communication between the user, the gearbox OEM and PROGNOST Systems diagnostic experts. In the following screenshots, the progression of the defect will be getting more visible.

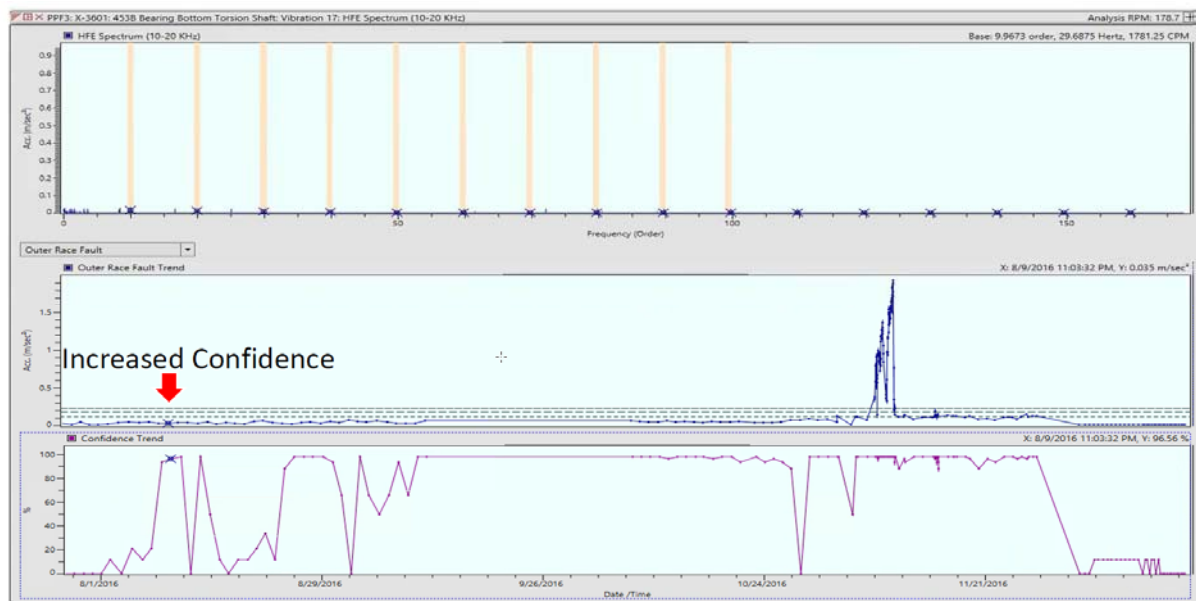
Increased Confidence Factor in the mid of August

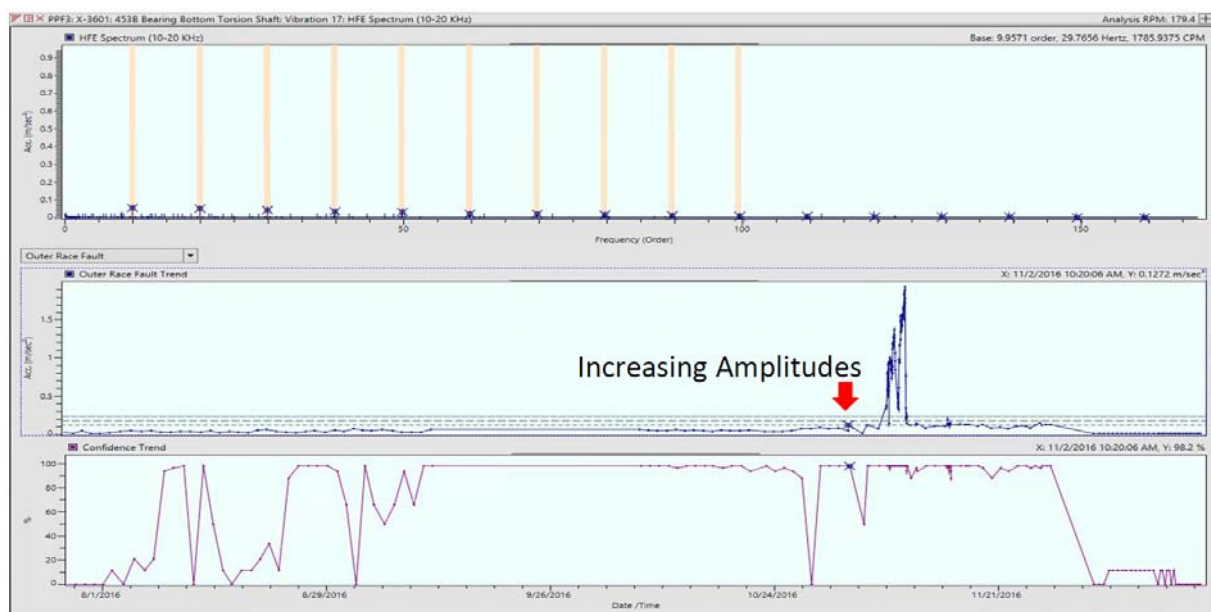
First increased amplitudes at the beginning of November

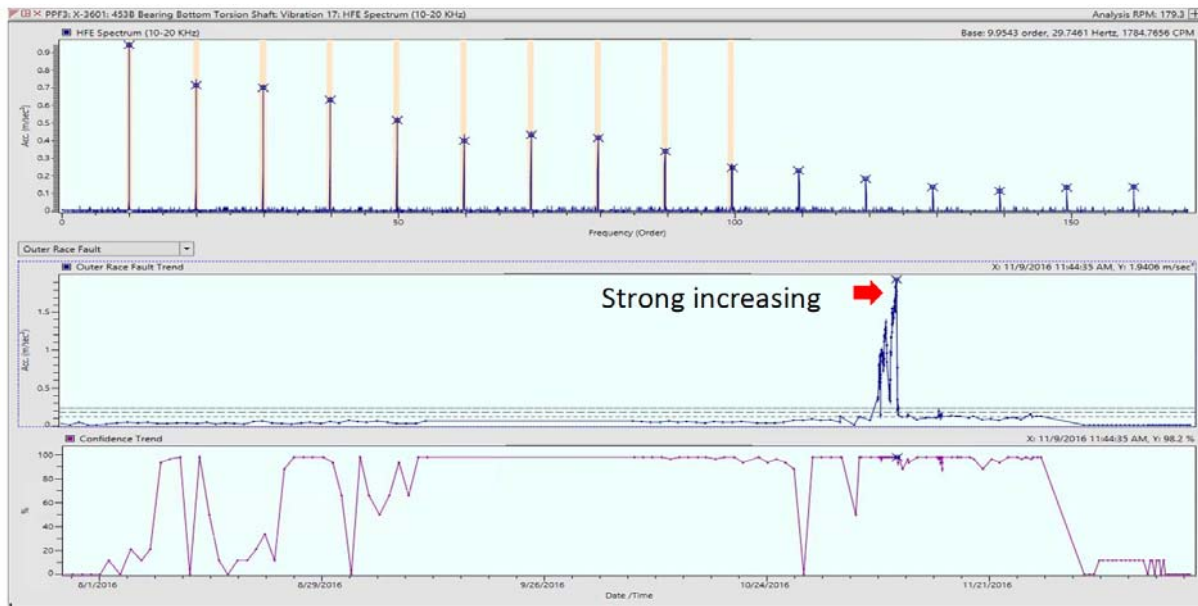
Strong increased Amplitudes a few days later

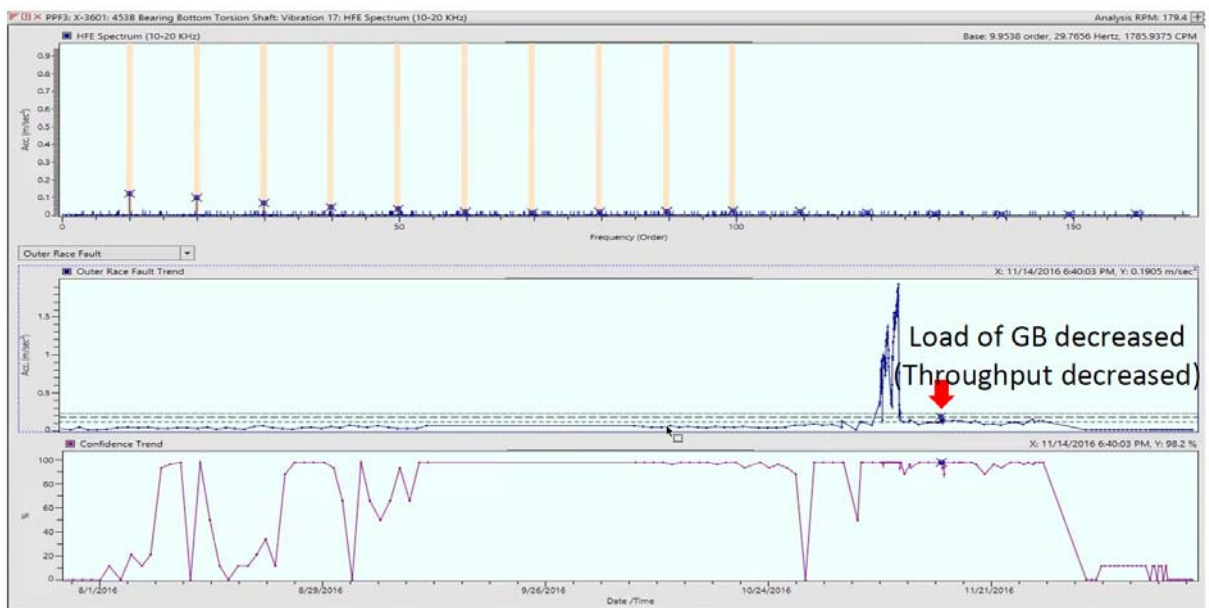
The load of the gearbox decreased / Throughput decreased

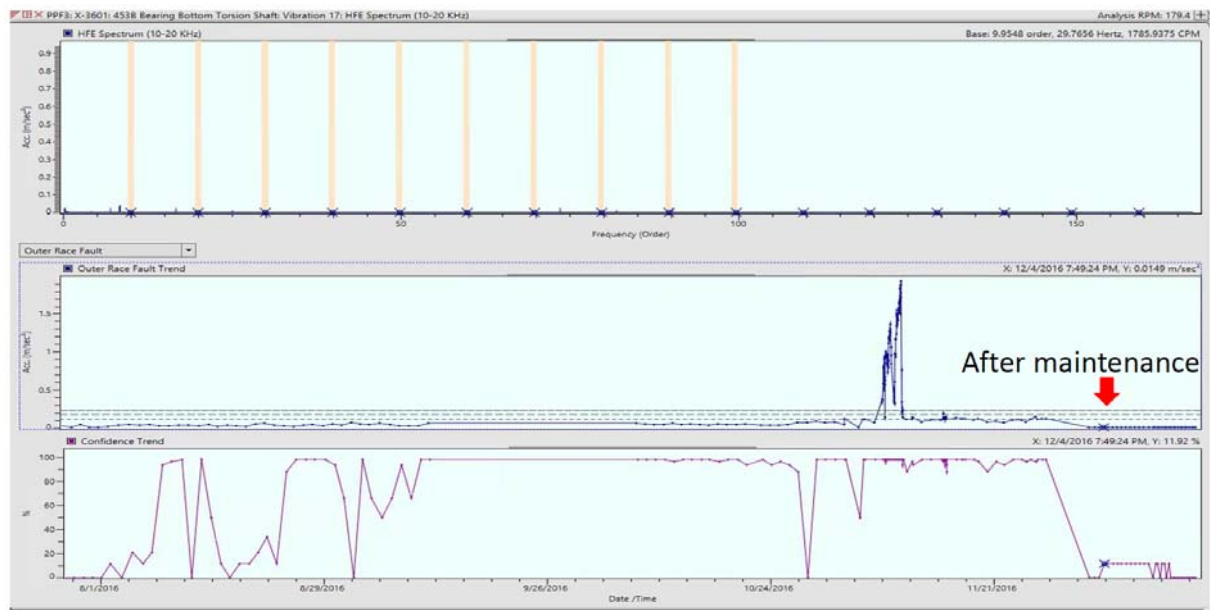
After maintenance, all values went back to normal condition

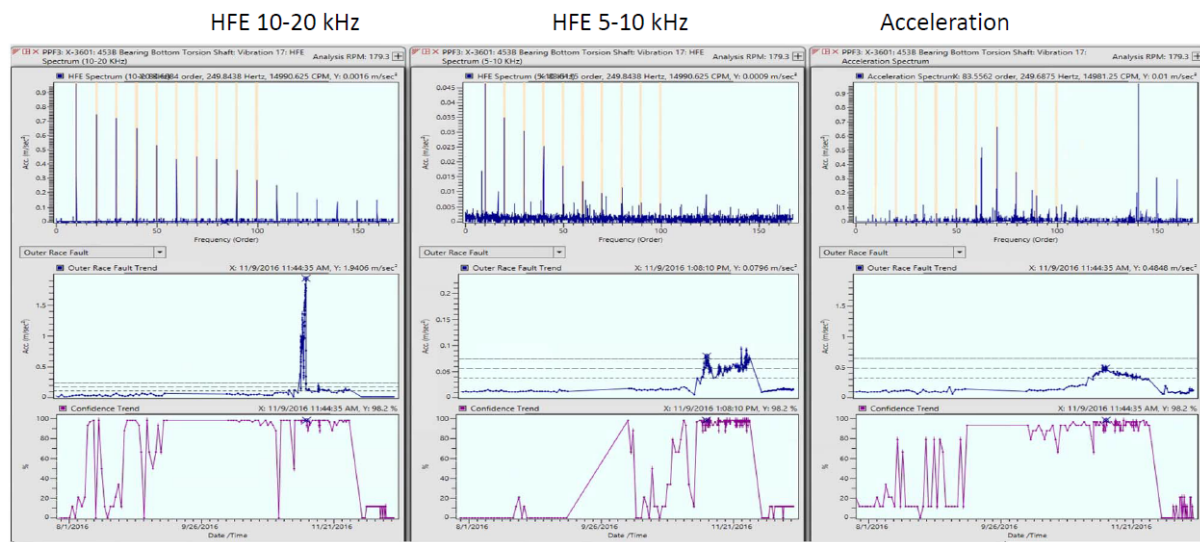
Comparison of HFE trends

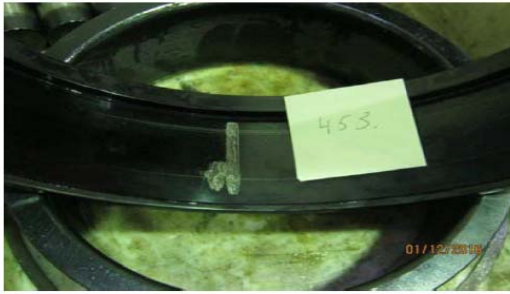
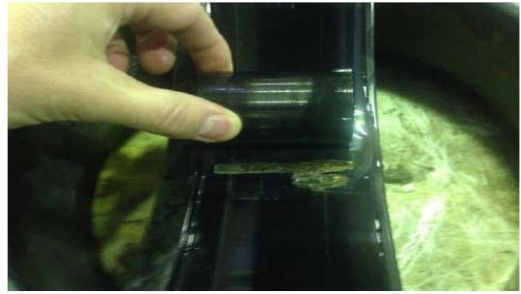
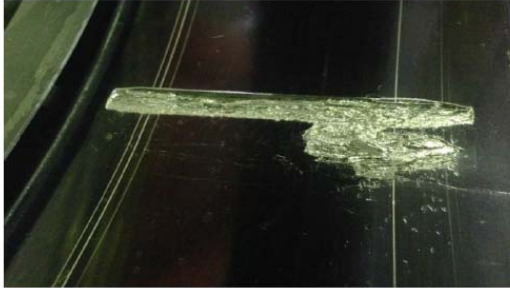
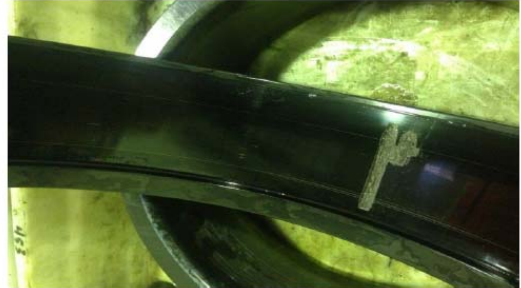
Damaged Bearing 453

A time period of three months just before any problem is visible on the gearbox showed how early and effective the PROGNOST®-Predictor detected the first indications of the upcoming failure. The time period and the continuous monitoring allowed the customer to schedule the required maintenance stop before the gearbox failed. The question here was when to shut down and what damage is acceptable!
