## **Early, Automatic, Online**

**Detection** > Successful avoidance of major secondary damages using proximity measurements to detect a partially fractured piston rod

BY DR. UWE LADWIG

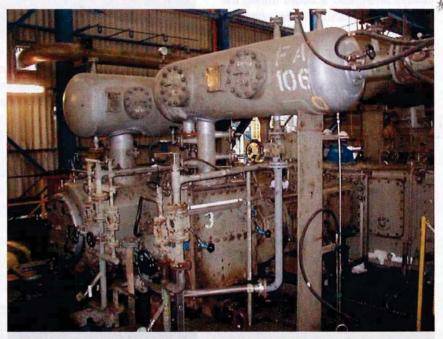
Thomassen reciprocating compressor.
